**ST PETER'S CHURCH, FARMINGTON,  
GLOUCESTERSHIRE**

**ARCHAEOLOGICAL WATCHING BRIEF**

C.A.T JOB: 0885  
C.A.T REPORT: 991071

SEPTEMBER 1999

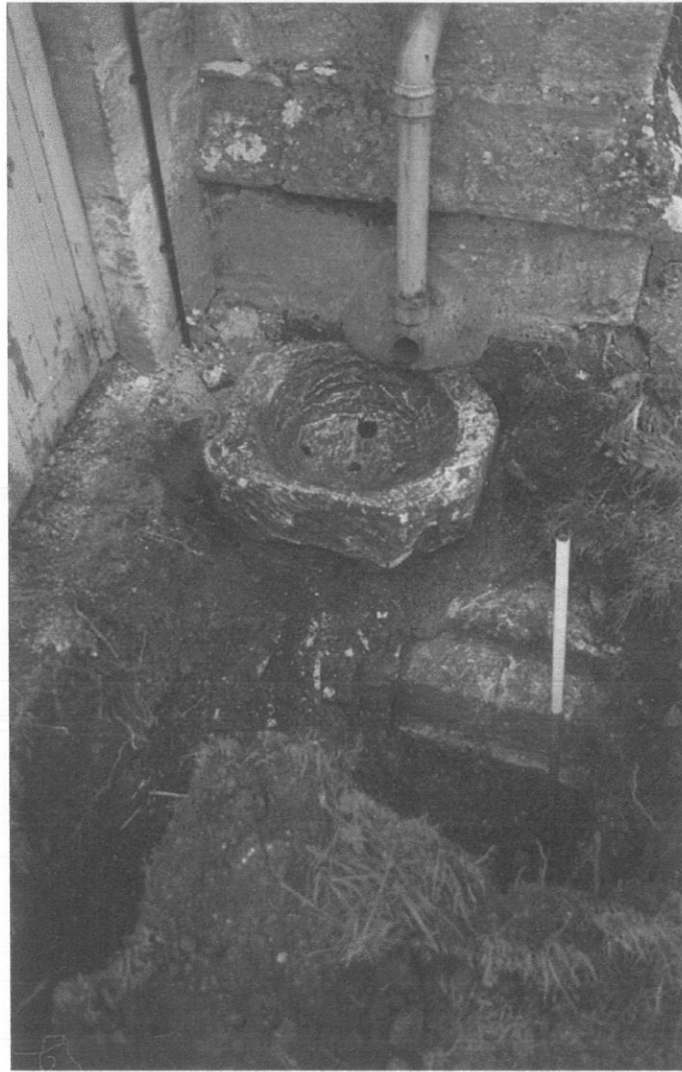
Plate 1: Test pit 1. Re-used font bowl and foundations of church tower

2.1.1 At a distance of 0.50m north of the north-western corner of the tower, test pit 1 measuring 0.60m x 0.80m and 1.00m deep from the present ground surface was dug to accommodate the mat necessary for a lightning conductor on the tower (Figure 2, Plate 1). The pit was completely contained within the foundation trench for the western tower (fill of light yellow-brown sandy clay mixed with small and medium-sized angular limestone fragments) and in its southern face the tower footings were uncovered. The exposed remains comprised three stepped courses of mortared limestone ashlar, the middle course being chamfered. The courses continued below the base of the excavated pit.

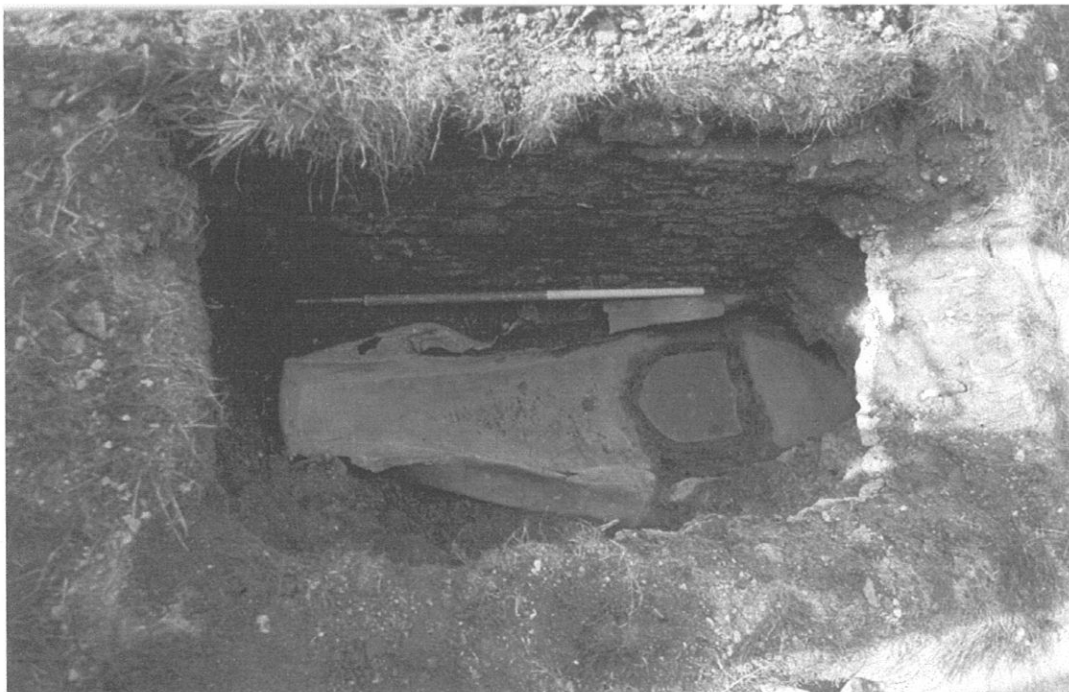
Plate 2: Test pit 2. Lined grave containing coffin of Charles Miller, d. 1778

To the south of the chancel, a stone-lined grave was encountered, containing the remains of the triple shell coffin of Charles Miller who died in 1778. Elements of a decorated stone tomb chest were found within the backfill of the disturbed grave.

2.4.2 An area of loose stone rubble filling a grave was soon revealed. The grave was seen to measure at least 1.50m x 0.80m and was excavated to a depth of 1.20m below present ground surface. The eastern and southern faces of the grave cut were lined with dry-stone walls formed of limestone. The western limit of the grave was not exposed, but the northern wall had collapsed into the void of the grave, presumably when disturbed for the construction of the drainage channel alongside the southern wall of the chancel. This had crushed and deformed the single lead casket observed in the grave (Plate 2). Poorly preserved wood was noted in the backfill, probably deriving from the wooden casket forming the outer layer of the triple shells traditionally used in vaults or lined graves (Litten 1991, 101). Four iron nails were retained from the backfilled material, but the majority of the evidence for the elaborate coffin furniture and upholstery fashionable on outer cases between 1725 and 1775 (Litten, 102) was recovered in association with a brass plaque in the form of a shield. This was engraved *Charles Miller esq/ Died 7th Oct. 1778/ Aged 58*. Between this escutcheon and the surface of the lead coffin was poorly preserved wood. When the escutcheon was lifted impressions of fabric could be seen in the remains of the wood and a number of brass-headed tacks were seen penetrating this substance, presumably used to attach the fabric covering to the outer wooden shell and commonly arranged in decorative patterns. No skeletal material was exposed
